Cerritos Channel: The Project That Refused to Fail

The Cerritos Channel Transmission Relocation project succeeded thanks to innovation, collaboration and expertise.

By **CHRISTOPHER A. MILLER**, Hill International Inc.

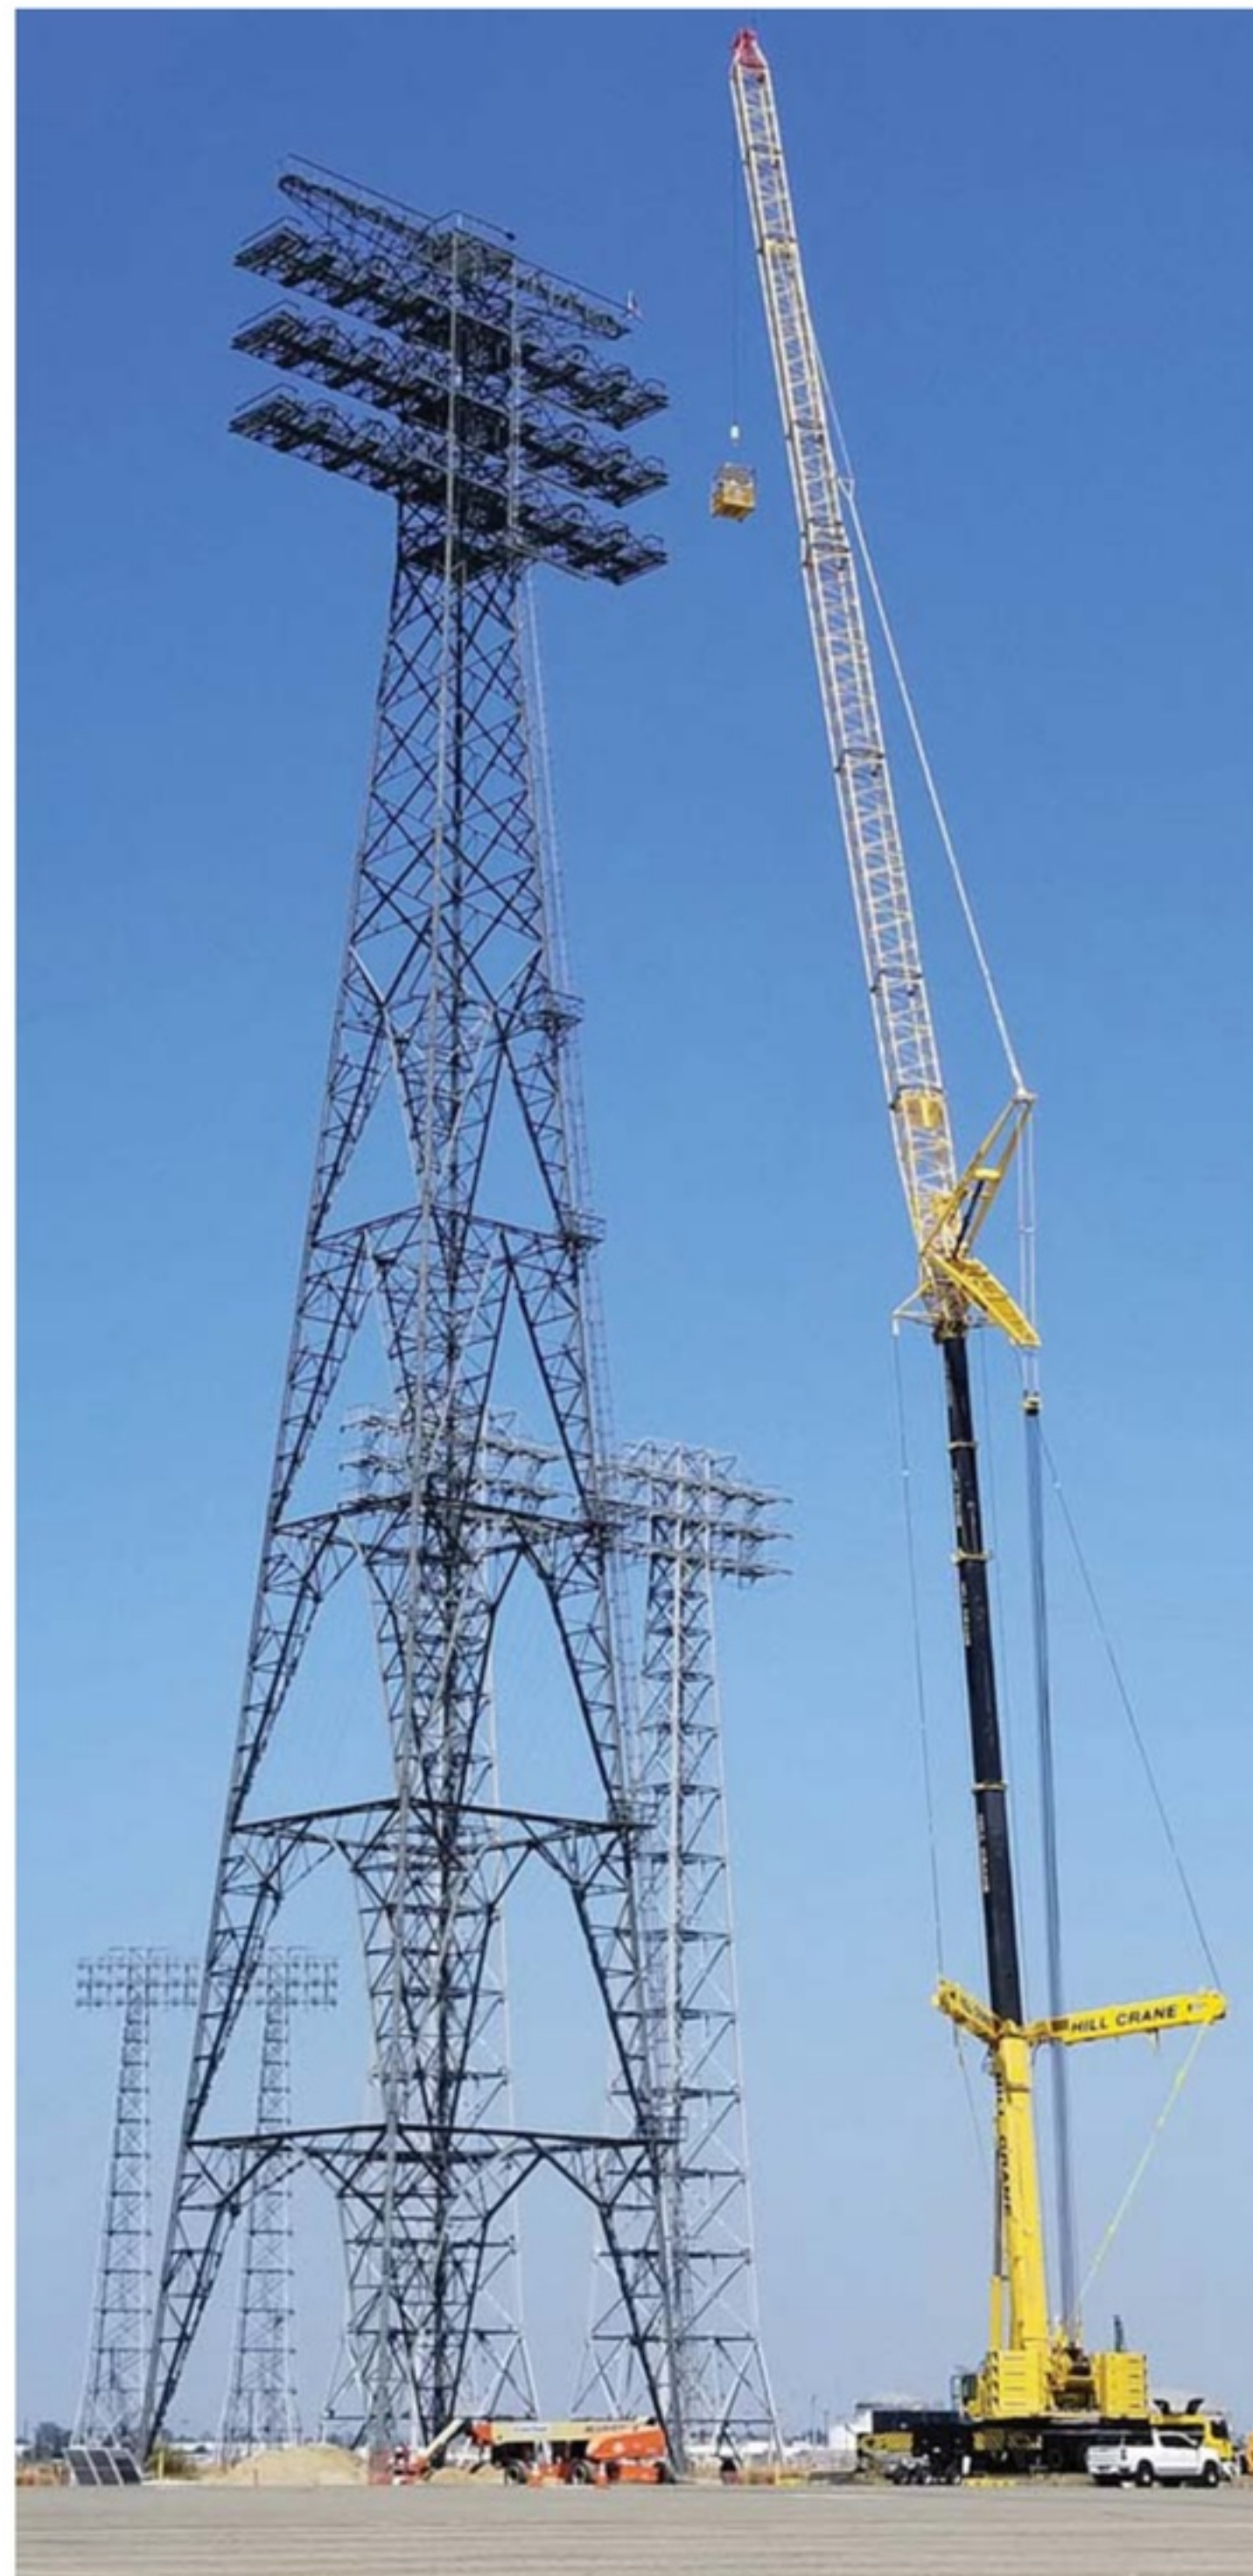
Completed 394-ft tower, the tallest in Southern California.

- Installing two of the tallest transmission towers in Southern California, at 394 ft (120 m) each
- Placing new foundations for the towers on unique geological conditions, especially on the south bank of the channel, within an active seismic area
- Working on and around property owned by the POLB, the second-busiest port in the U.S — including the delivery and installation of a 500-ton crane in multiple locations
- Verifying work complied with strict California environmental requirements
- Completing all channel crossing work by March 31, 2021, per POLB requirements
- Doing all this work during the COVID-19 pandemic, while wildfires and social unrest raged throughout the state.

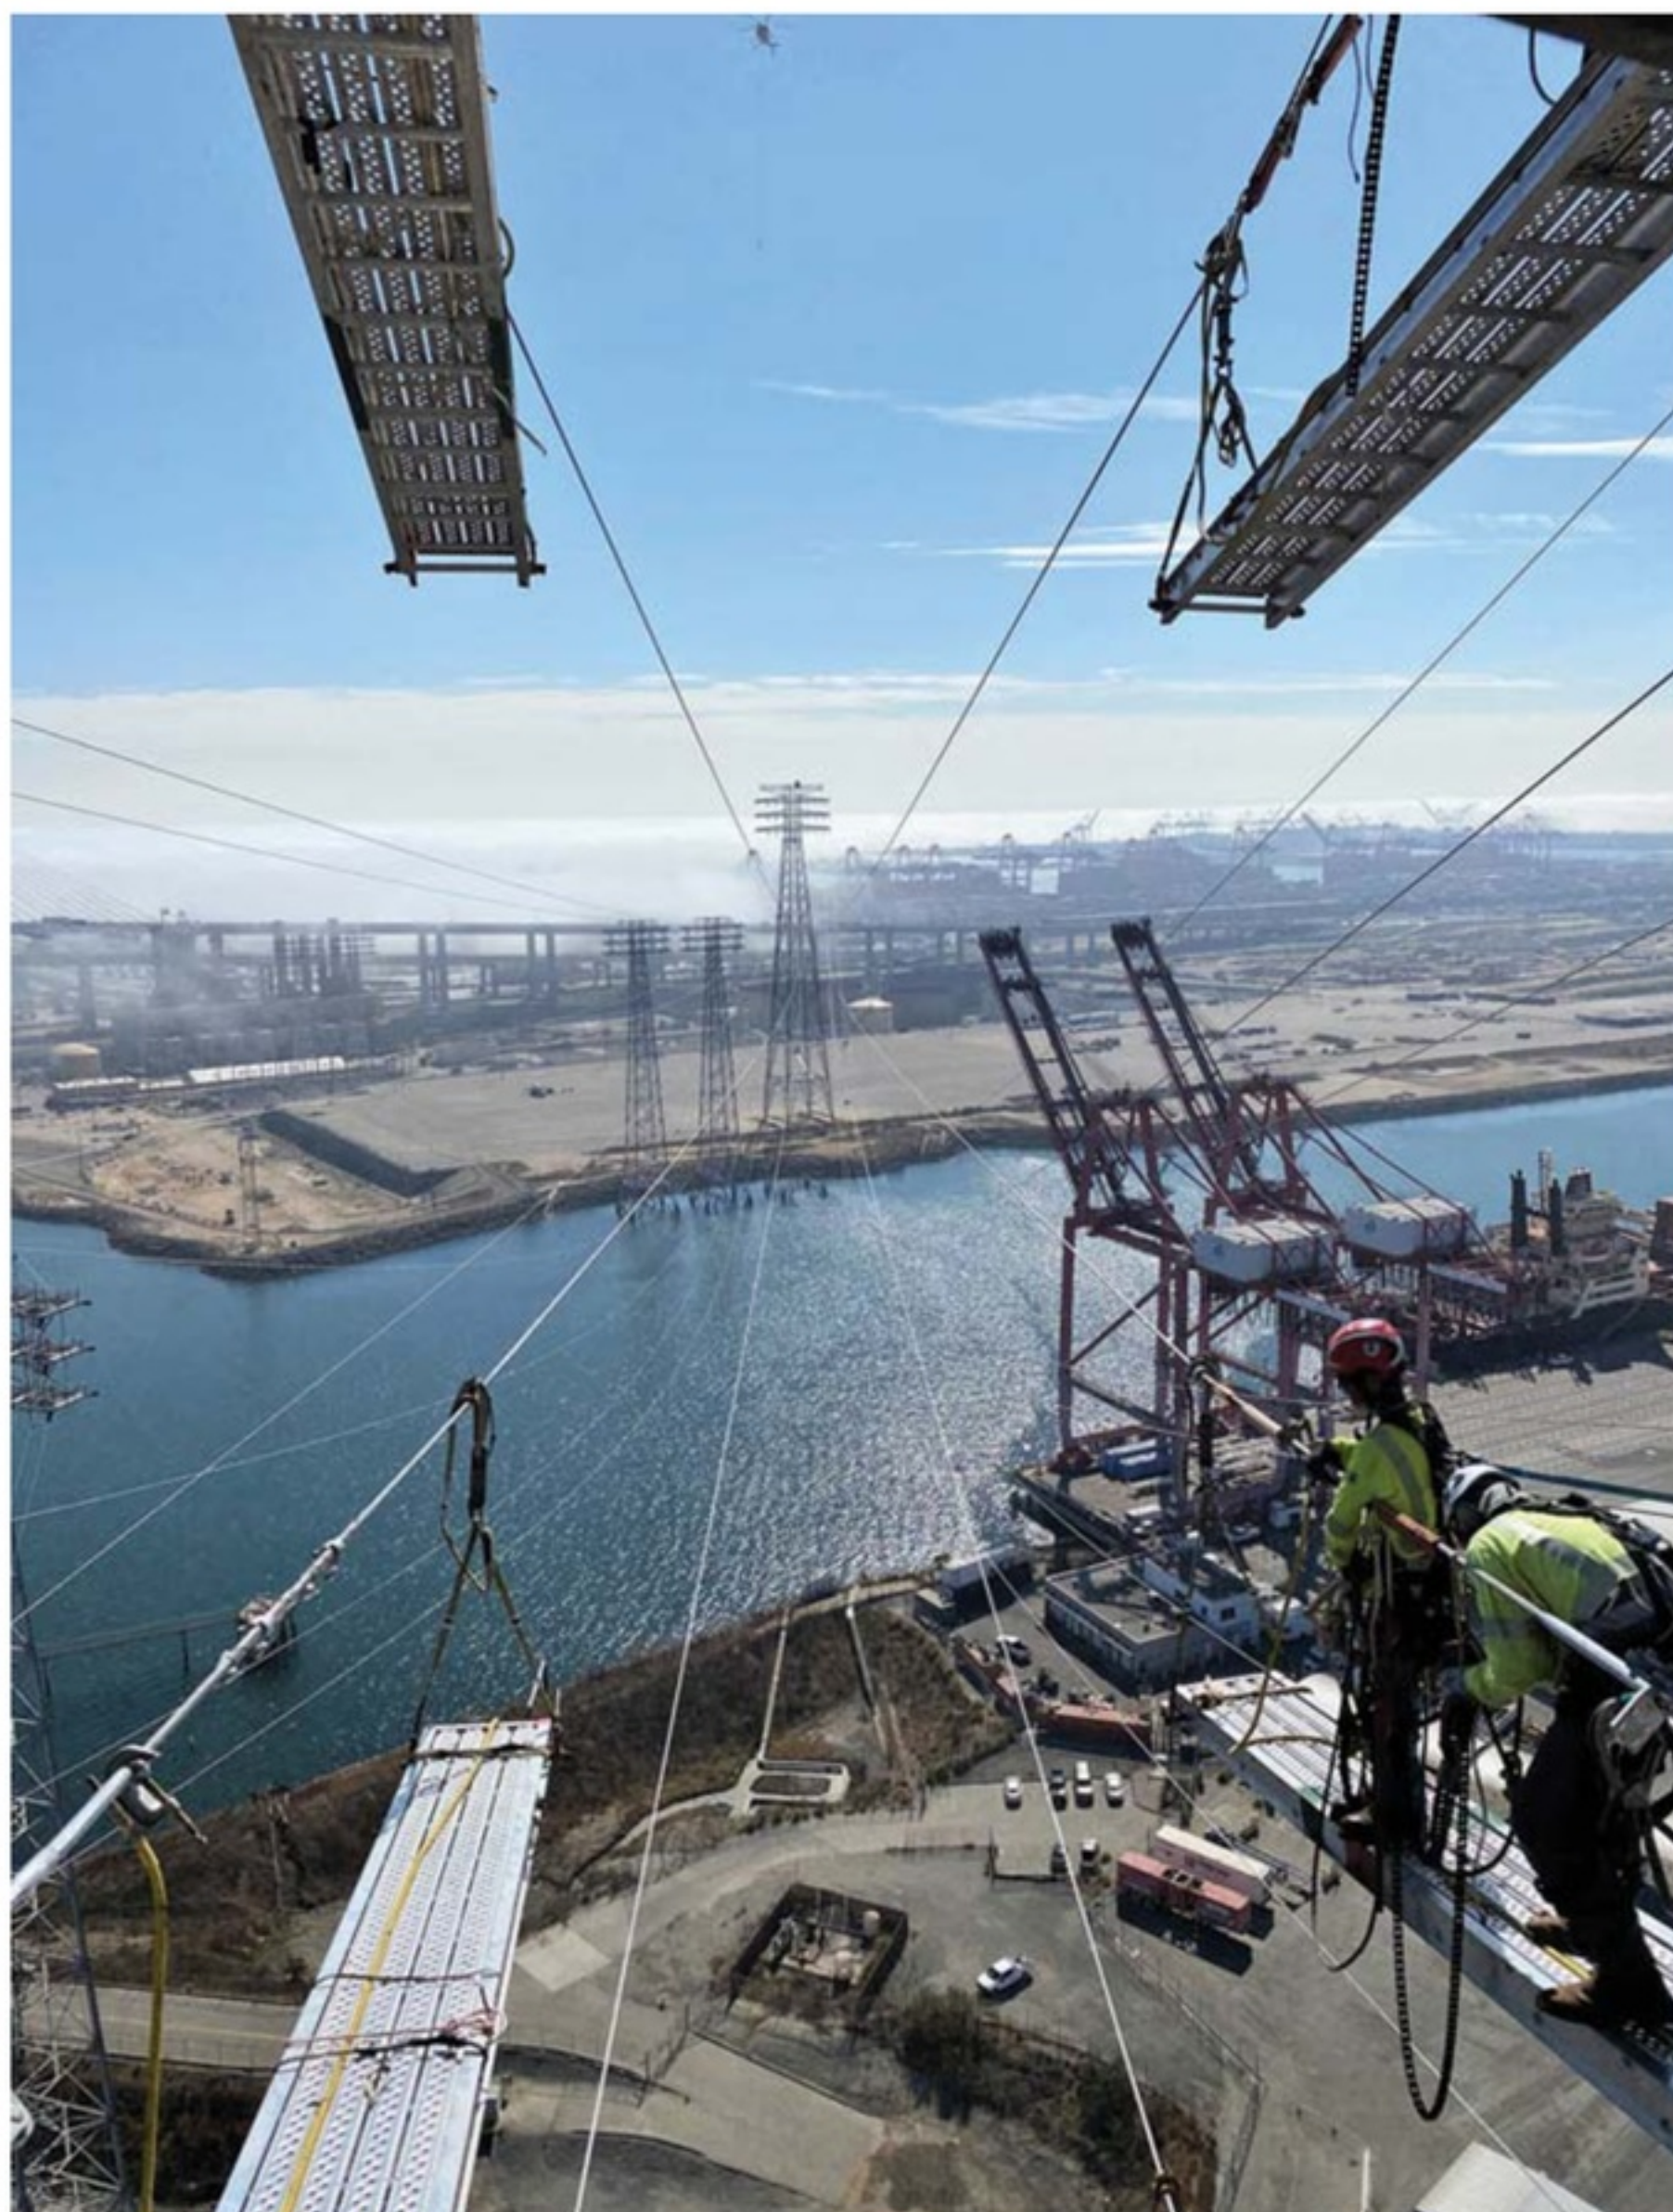
View from conductors overlooking Cerritos Channel.

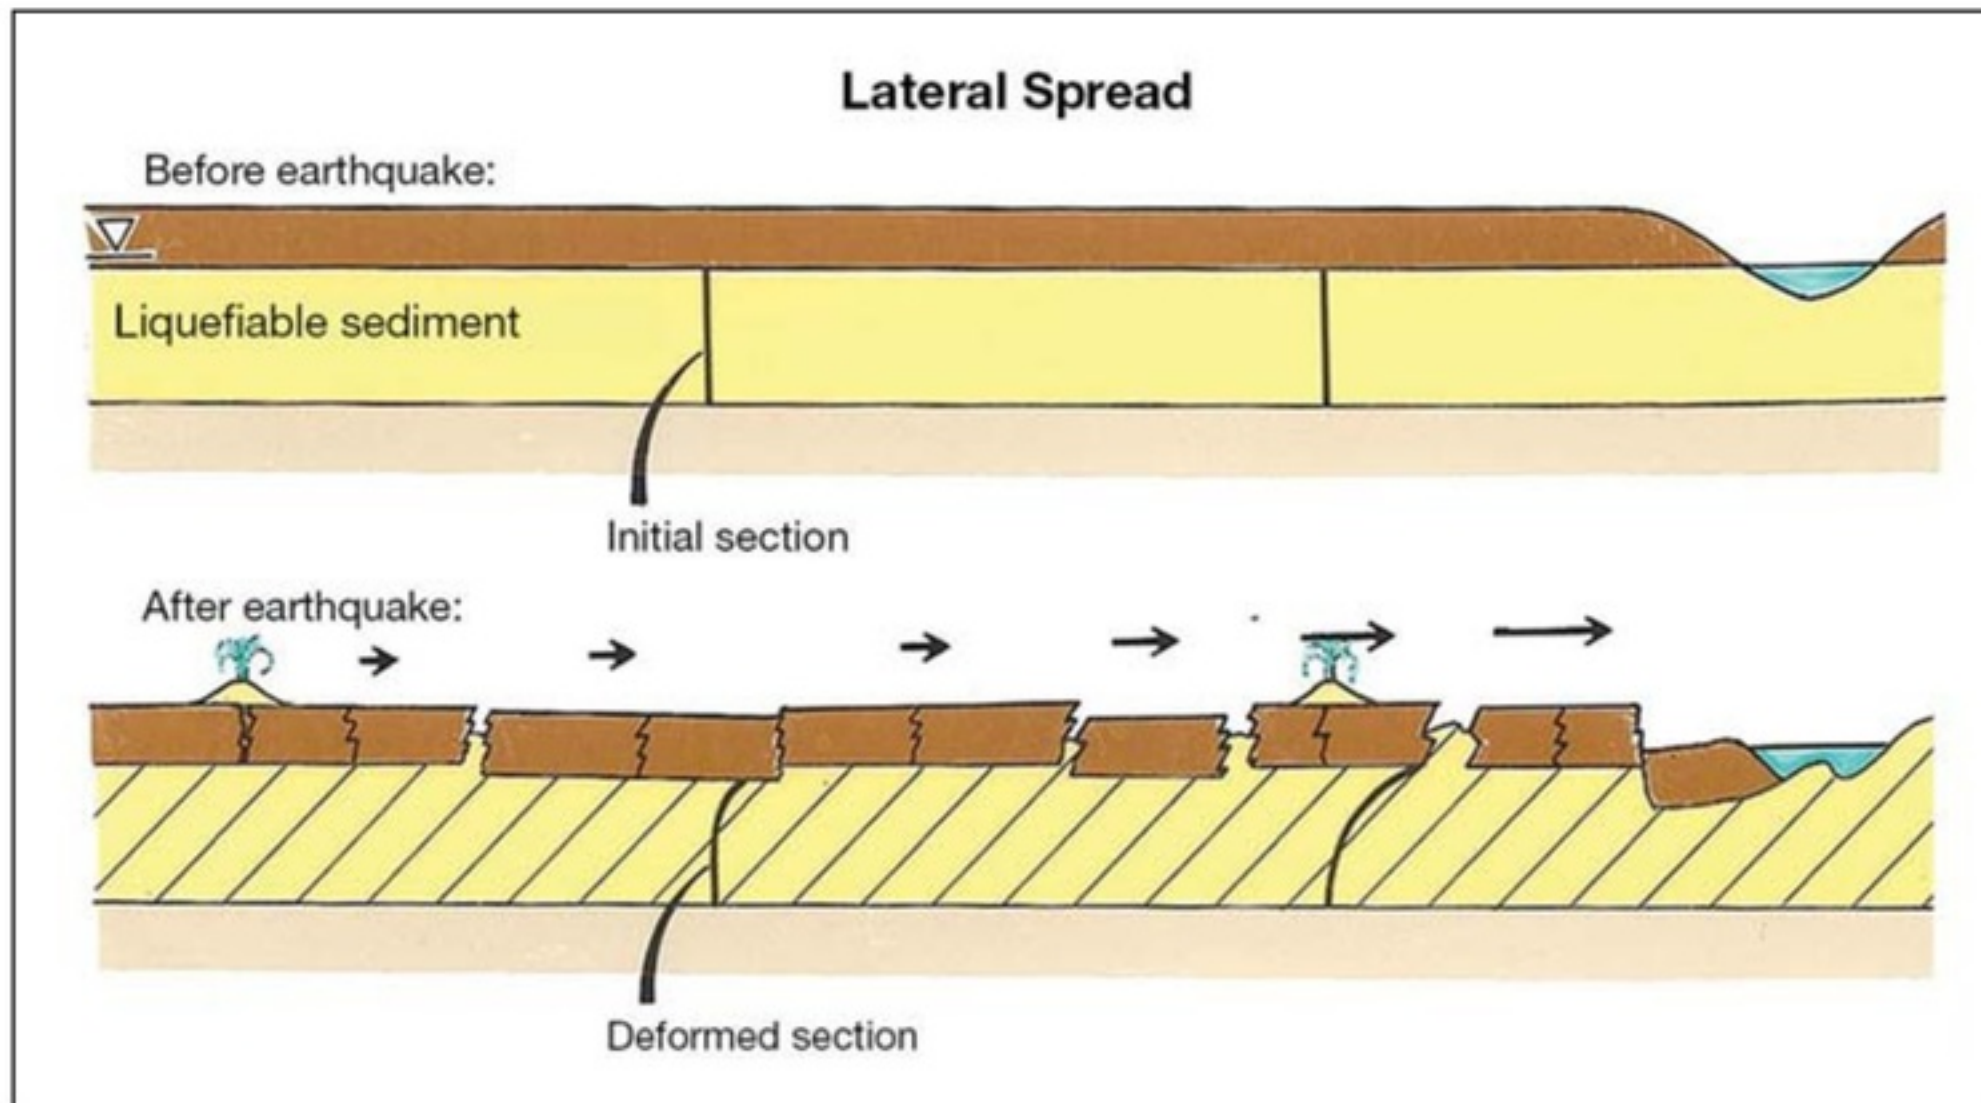
Lateral spread before and after earthquake. Source: Youd, T. L. (1984). "Geologic Effects—Liquefaction and Associated Ground Failure." Geologic and Hydrologic Hazards Training Program, U.S. Geological Survey, Washington, D.C., 210-232.

However, a later geotechnical investigation showed liquefiable soils extended much deeper than originally anticipated. Because of the loose soil and shallow ground water, seismic vibrations can make the soil behave like a liquid (liquefaction), losing its ability to support weight. This liquefaction near a free edge, such as a channel or cliff, can cause lateral spreading or sliding in the direction of the slope.

With the new geotech data in hand, calculations showed seismically induced lateral spreading of more than 6 ft (1.8 m) — or 867% more than the 6-inch (152-mm) maximum allowed — could occur and needed to be mitigated structurally within a new design.

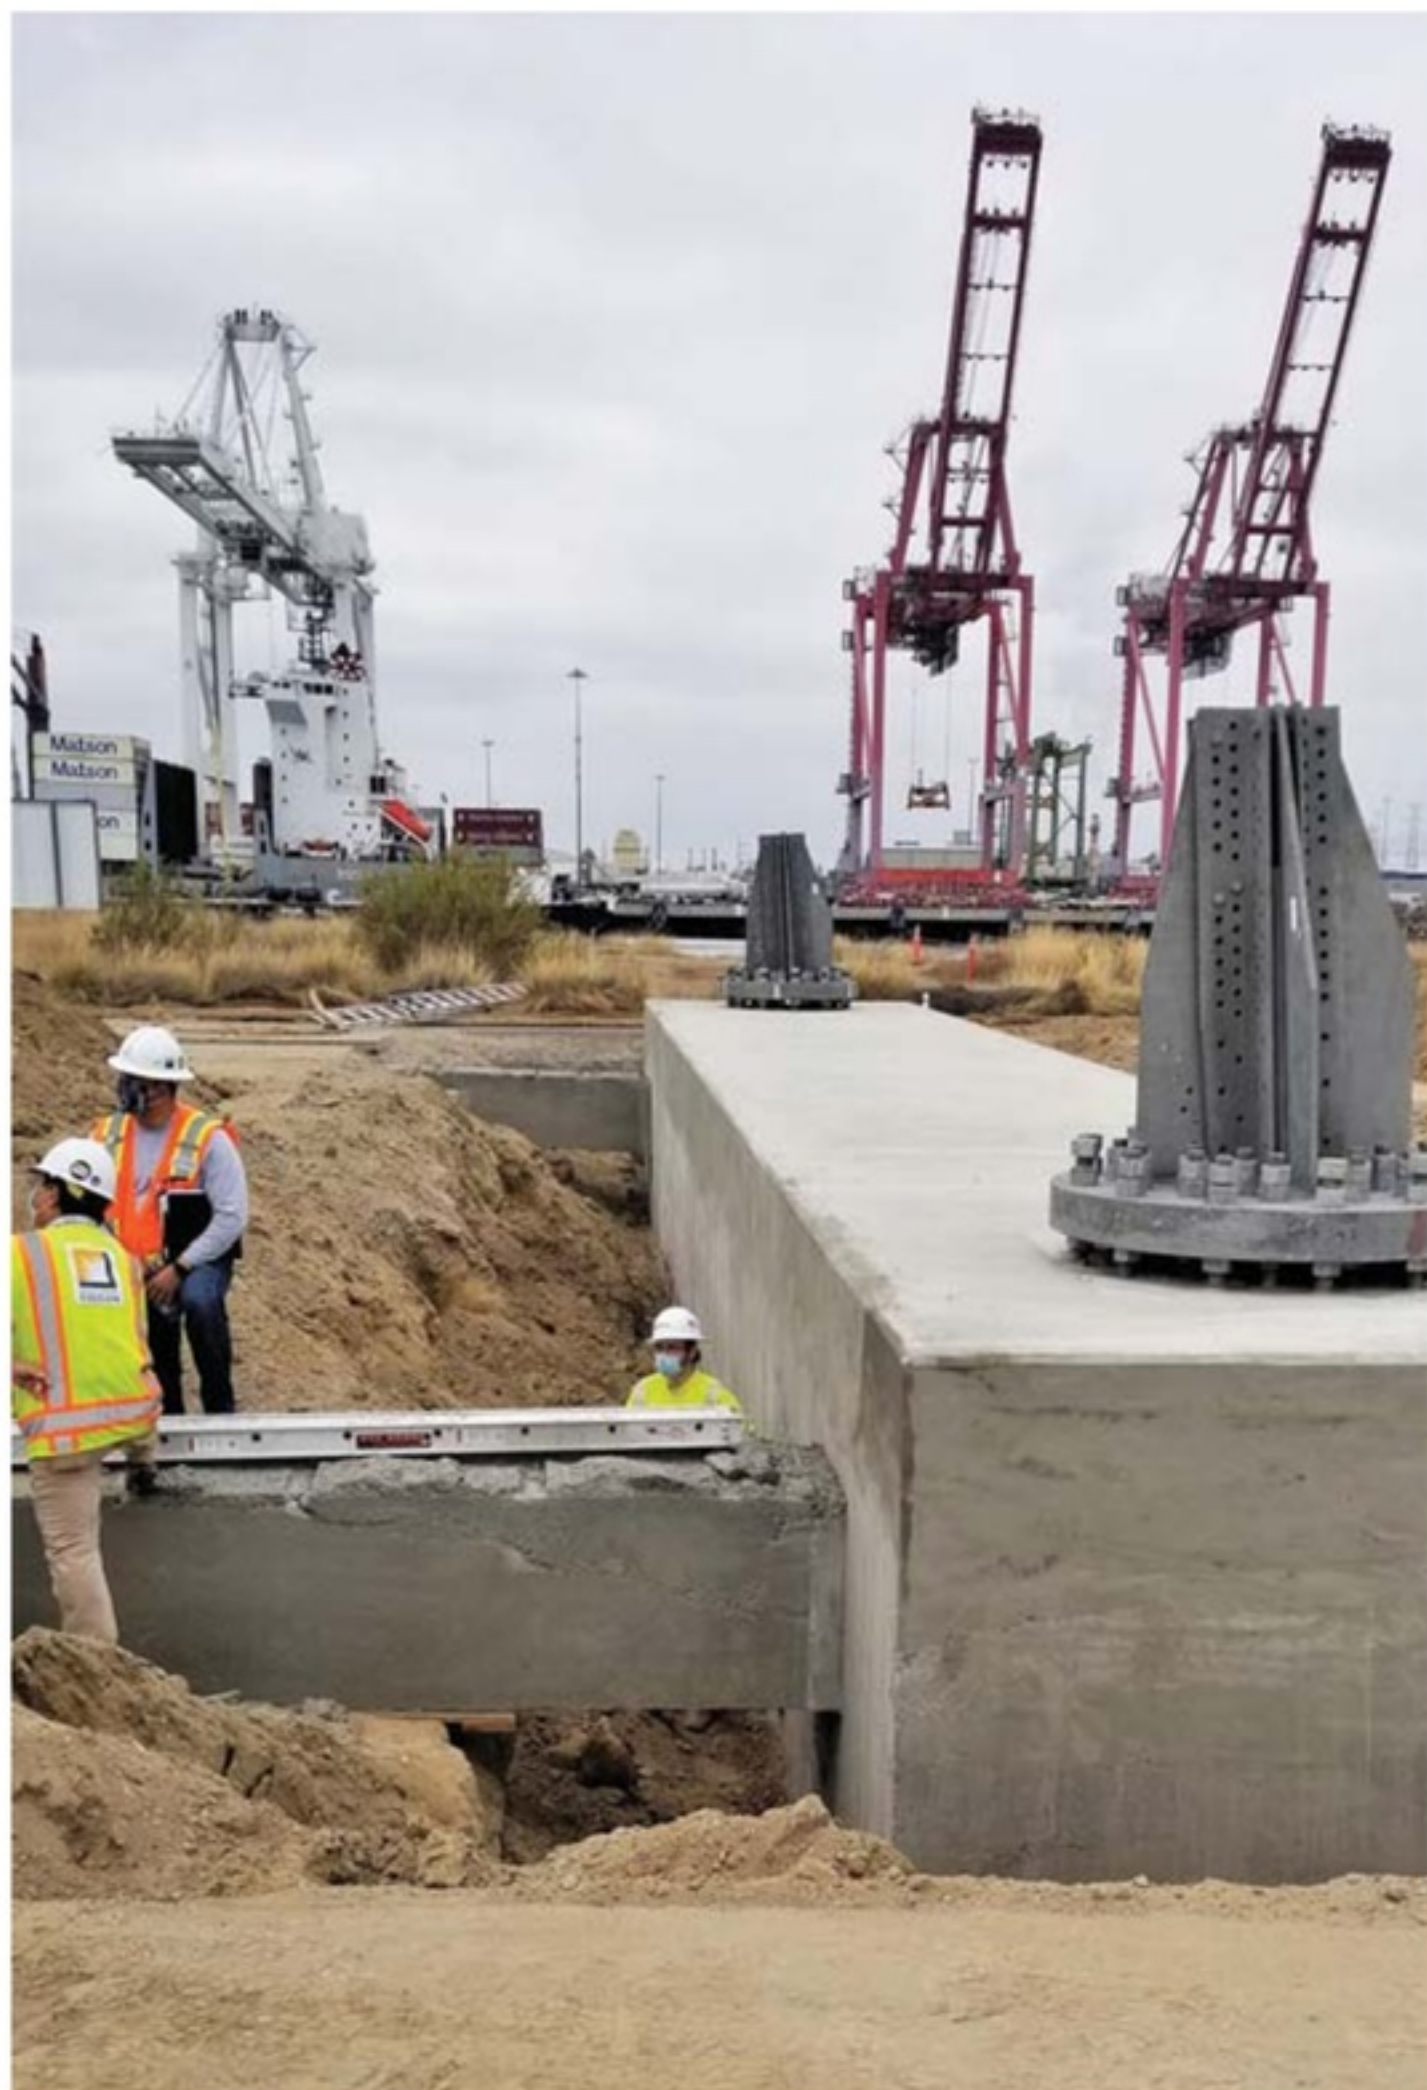
Large grade- and tie-beam system at southern tower.

The design solution for the southern tower site included fully cased, large-diameter drilled shafts — approximately 10 ft (3 m) in diameter and 115 ft (35 m) embedded depth — that contained 1.25-inch (31.75-mm) thick steel casing, a 27-ton rebar reinforcement cage, and 660 tons of concrete at each tower leg connected by a large grade- and tie-beam system incorporating another 1700 tons of concrete. Notably, this design was not expected to withstand all lateral movement but instead would allow for a small, uniform lateral displacement, with all tower legs moving together, that would permit the structure to remain usable after an earthquake.

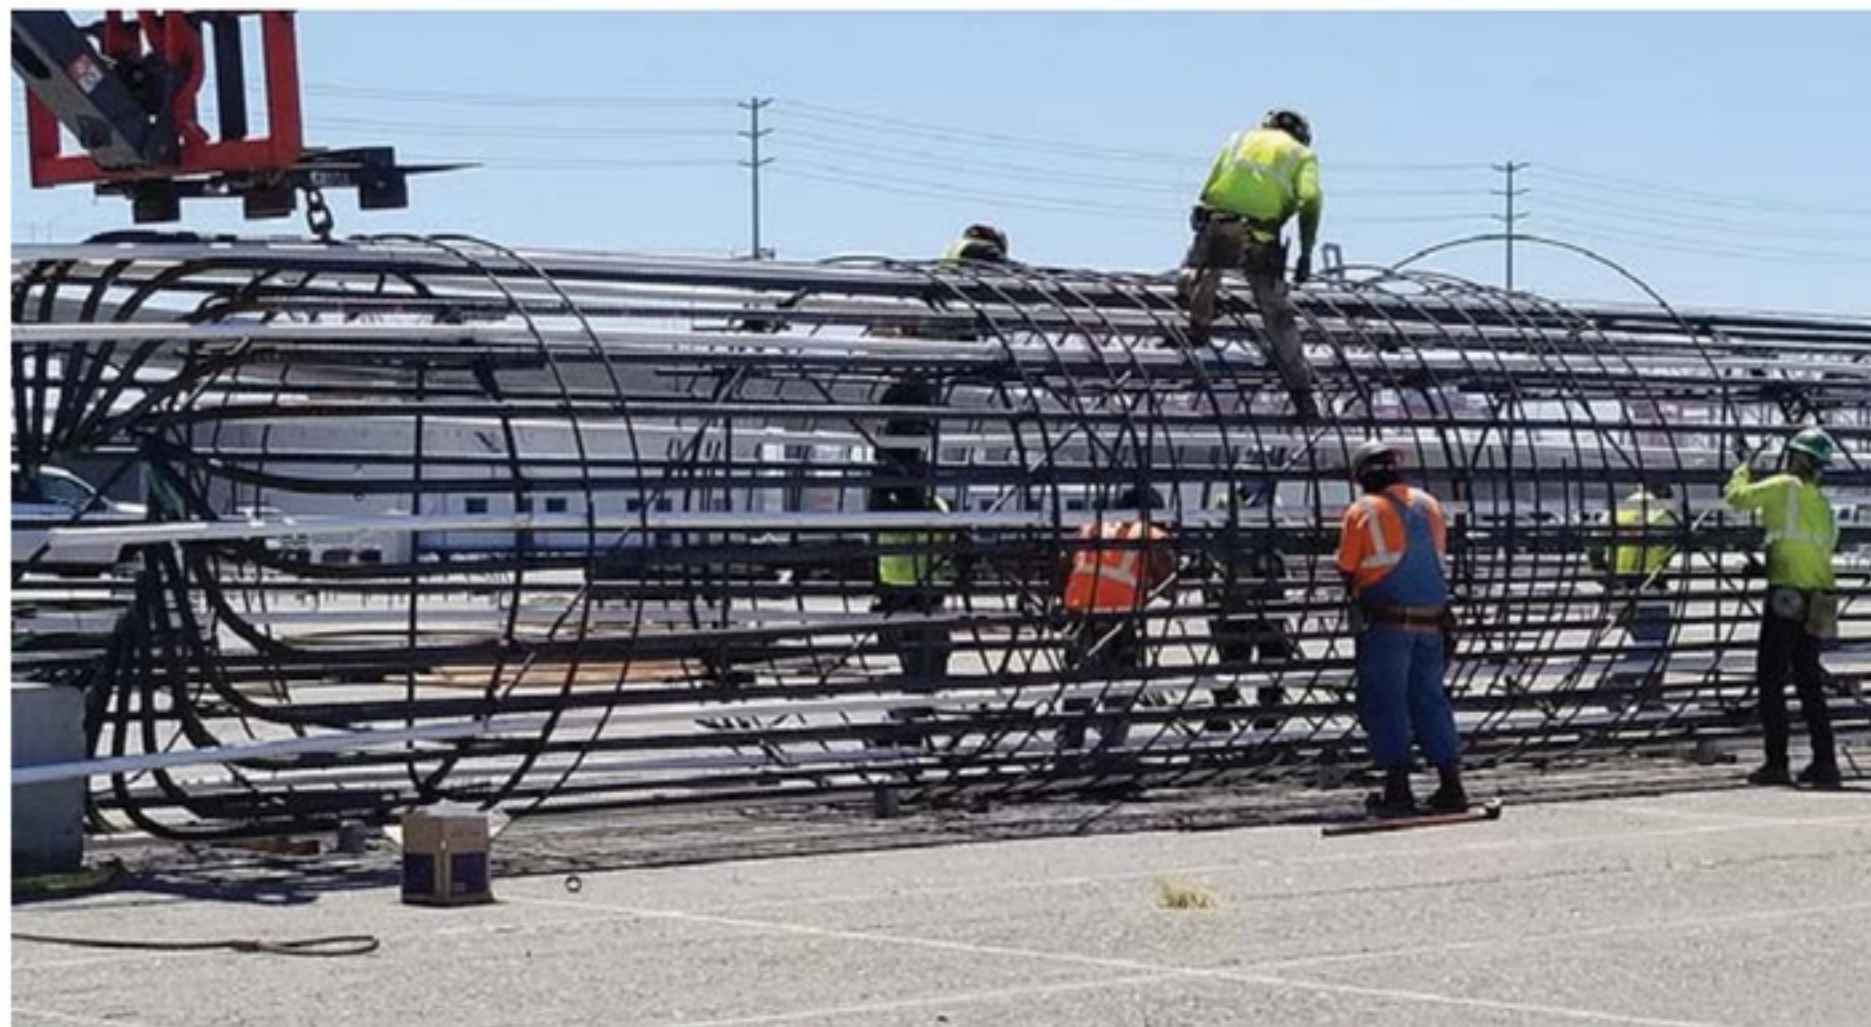
Rebar cage assembly.

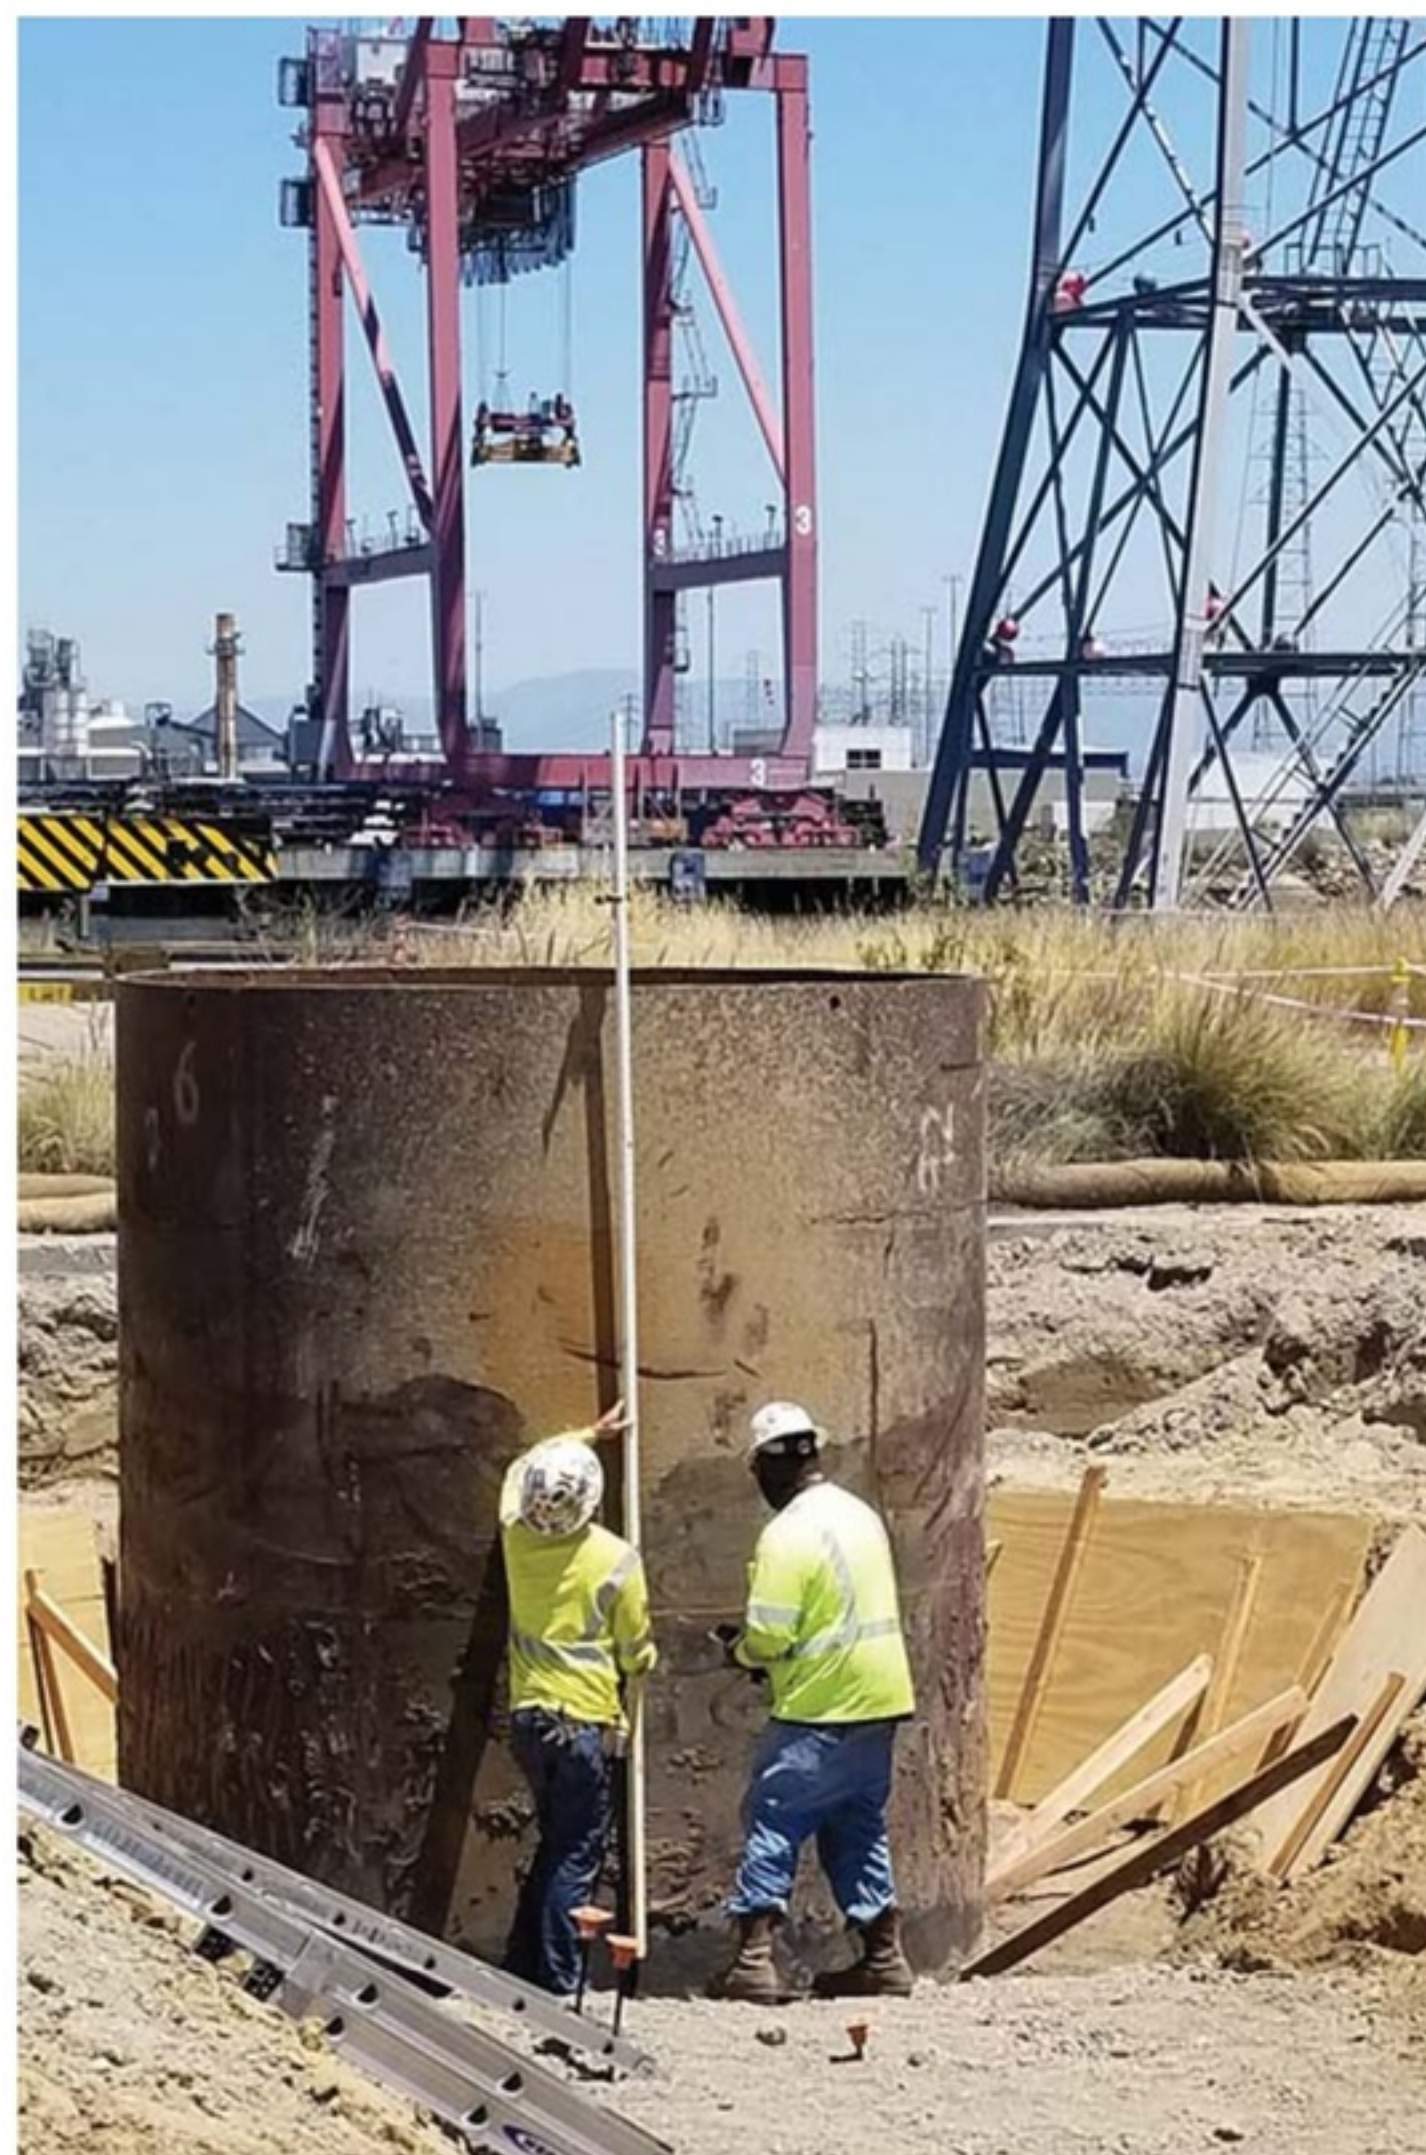
Leg for tie and grade beams.
